FREQUENTLY ASKED QUESTIONS

ETERNITY Range of IP-PBX

How to Resolve “Please Wait” or “Header Failed” issue on DKP?

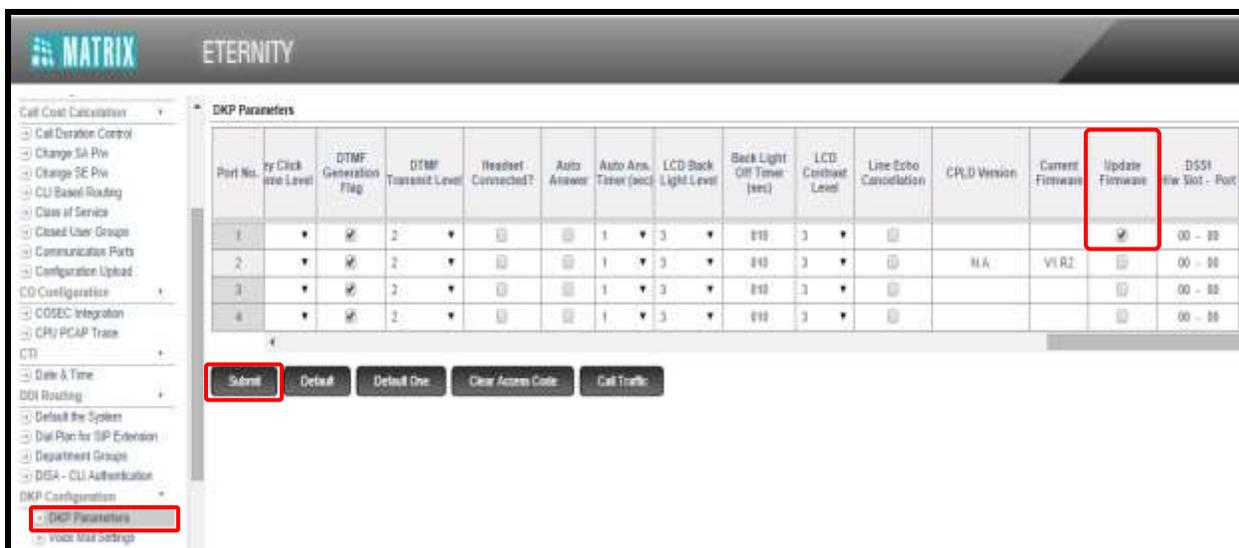
Case1: DKP fails to boot up during/after the upgrade and “Header Failed” message is shown on the LCD of the DKP.

The above message indicates that there was some error during the upgrade. This error can be because of power failure, user having removed the DKP during the upgrade from one Port and connected it to some other DKP Port, etc.

Resolution Step1: In ETERNITY Jeeves go to **DKP Configuration** → **DKP Parameters**, click **Advance** and check the flag **Update Firmware** for upgrading the DKP on the port it is connected and **Submit** the page.

Resolution Step2: Remove DKP and reconnect it on the same DKP Port of ETERNITY. The Phone should start upgrading.
