# FREQUENTLY ASKED QUESTIONS

ETERNITY Range of Products

# How to troubleshoot CLI detection issues in ETERNITY?

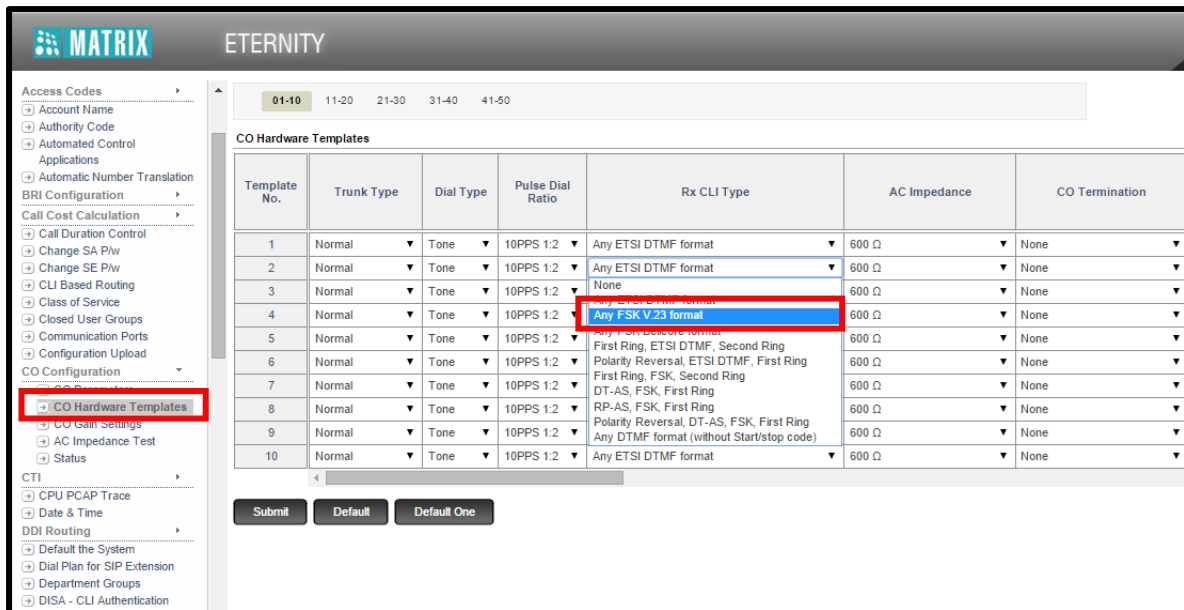
**Step 2:** Go to 'CO Configuration' followed by 'CO Hardware Templates' and vary 'Rx CLI Type' and check the CLI by making incoming test call for each option.

The screenshot shows the ETERNITY web interface. On the left, a navigation menu is visible with 'CO Parameters' highlighted. The main content area displays a table of CO Parameters for various ports. The 'CO Hardware Template' column for all ports is set to '02', which is highlighted with a red box in the image.
